## **ASBESTOS CLEARANCE CERTIFICATE INSPECTION PASS**

**Project/Location:** 115 Gladstone Street, Fyshwick, ACT 2609

**Job Number:** H2466

**Date(s) and Description of Work:** Removal/remediation of non-friable asbestos cement sheet from the ceiling in the kitchenette, ceiling in the hallway to the ablutions and the ceiling in the ablutions and shower. Removal of debris and packers under the site office subfloor and painting/sealing of packers that was not able to be removed.

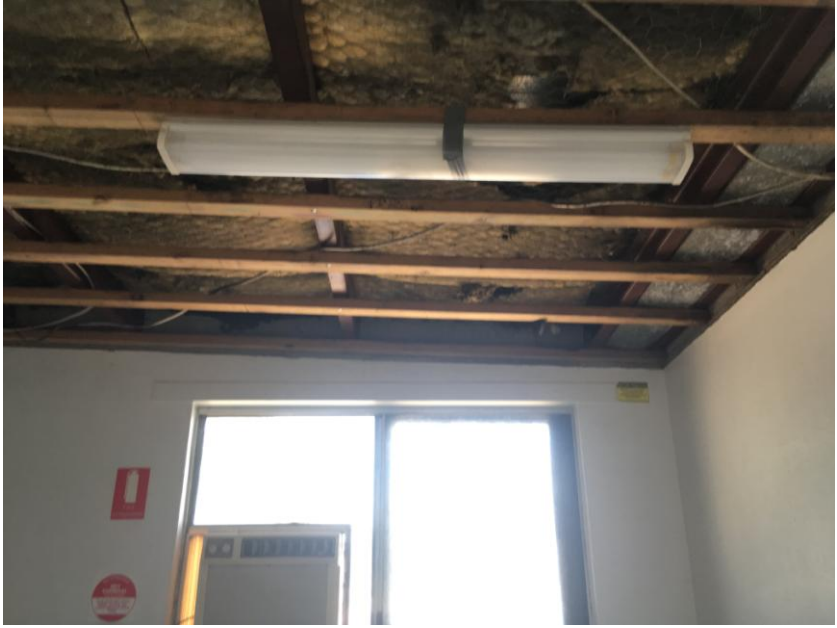
PHOTO NO	LOCATION DESCRIPTION	PHOTOGRAPH
1	After removal of non-friable asbestos cement sheet from the ceiling in kitchenette

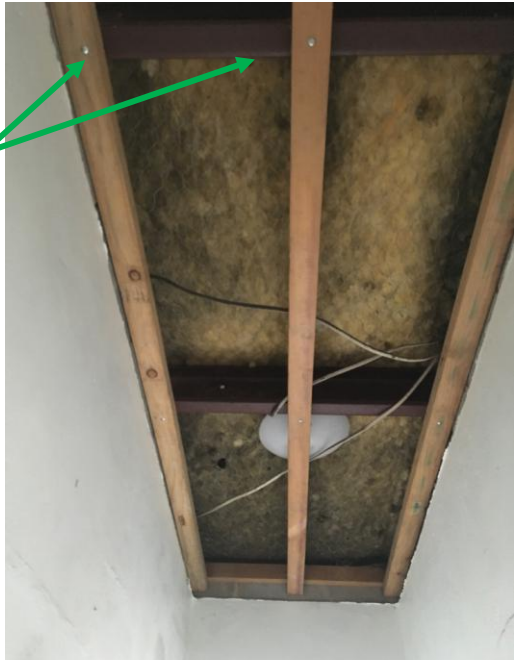
2	After removal of non-friable asbestos cement sheet from the ceiling in hallway joining the kitchenette and the ablutions	<p data-bbox="715 1323 810 1384">Bolts not nails</p>

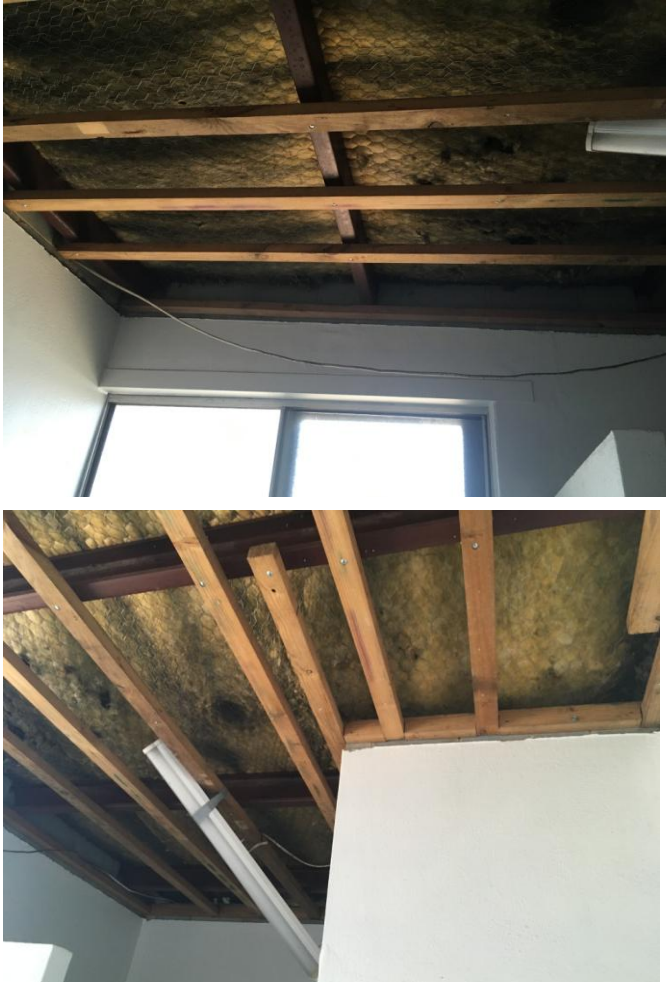
PHOTO NO	LOCATION DESCRIPTION	PHOTOGRAPH
3	After removal of non-friable asbestos cement sheet from the ceiling in the ablutions

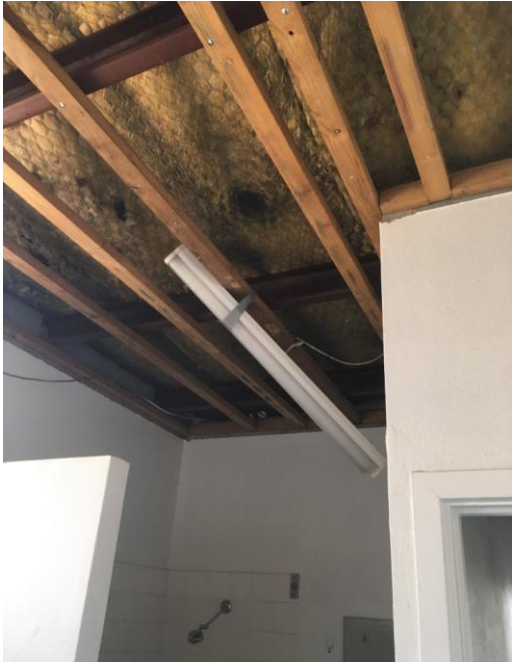
4	After removal of non-friable asbestos cement sheet from the ceiling in shower

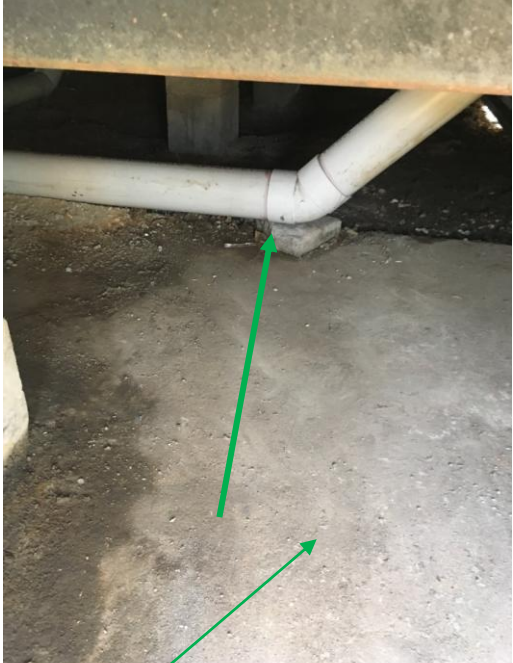
PHOTO NO	LOCATION DESCRIPTION	PHOTOGRAPH
5	After removal of non-friable asbestos cement sheet packers under the office subfloor

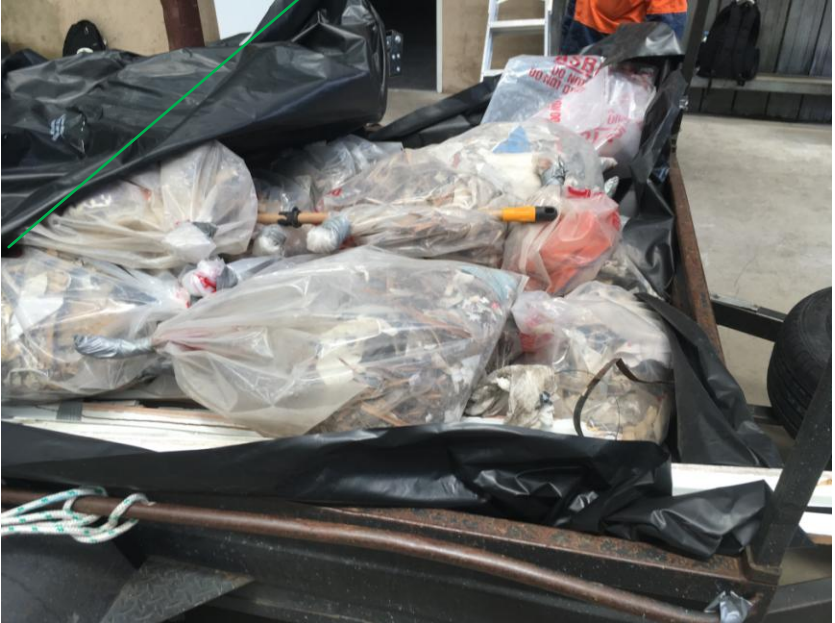
6	After removal of non-friable asbestos cement debris under the office subfloor
